Relevant Experience and Track Record

Derwent Sailing Squadron Break-wall

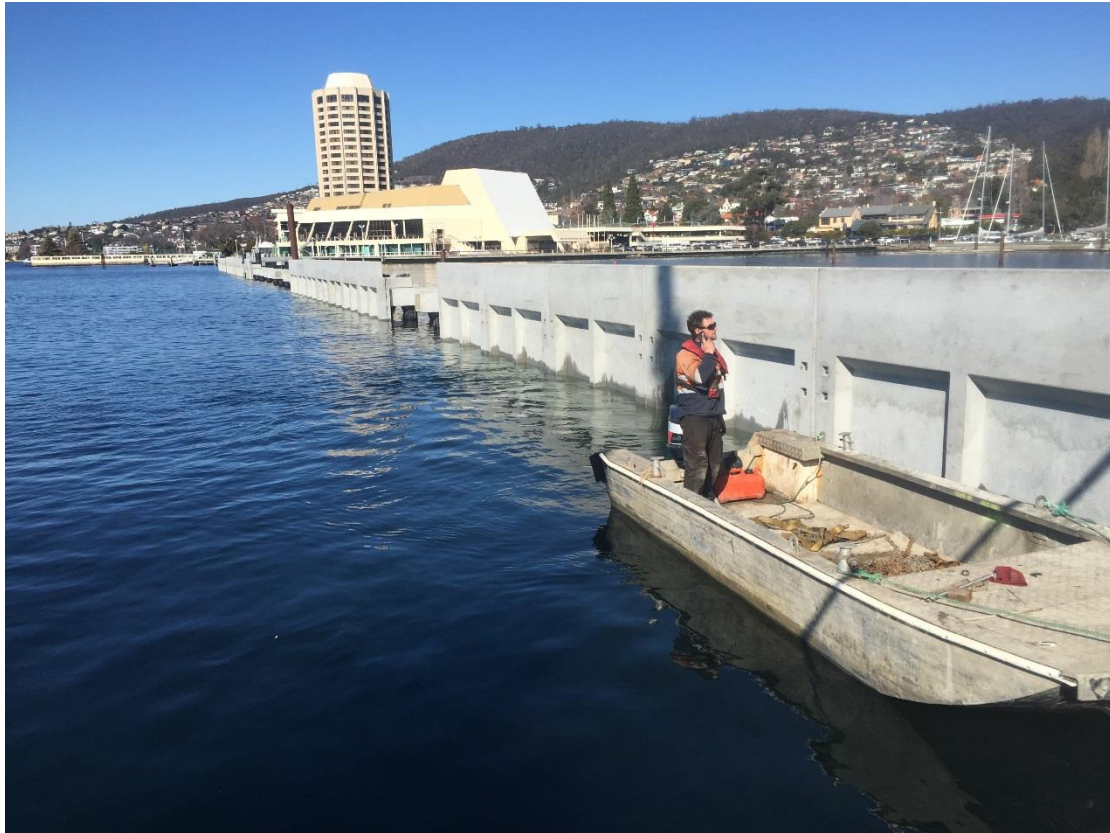
Description of works: 240m long piles break-wall. Average 10m water depth, painted steel steel piles driven, precast headstocks, concrete pour. 13t precast wave panels and underwater bolted connections.

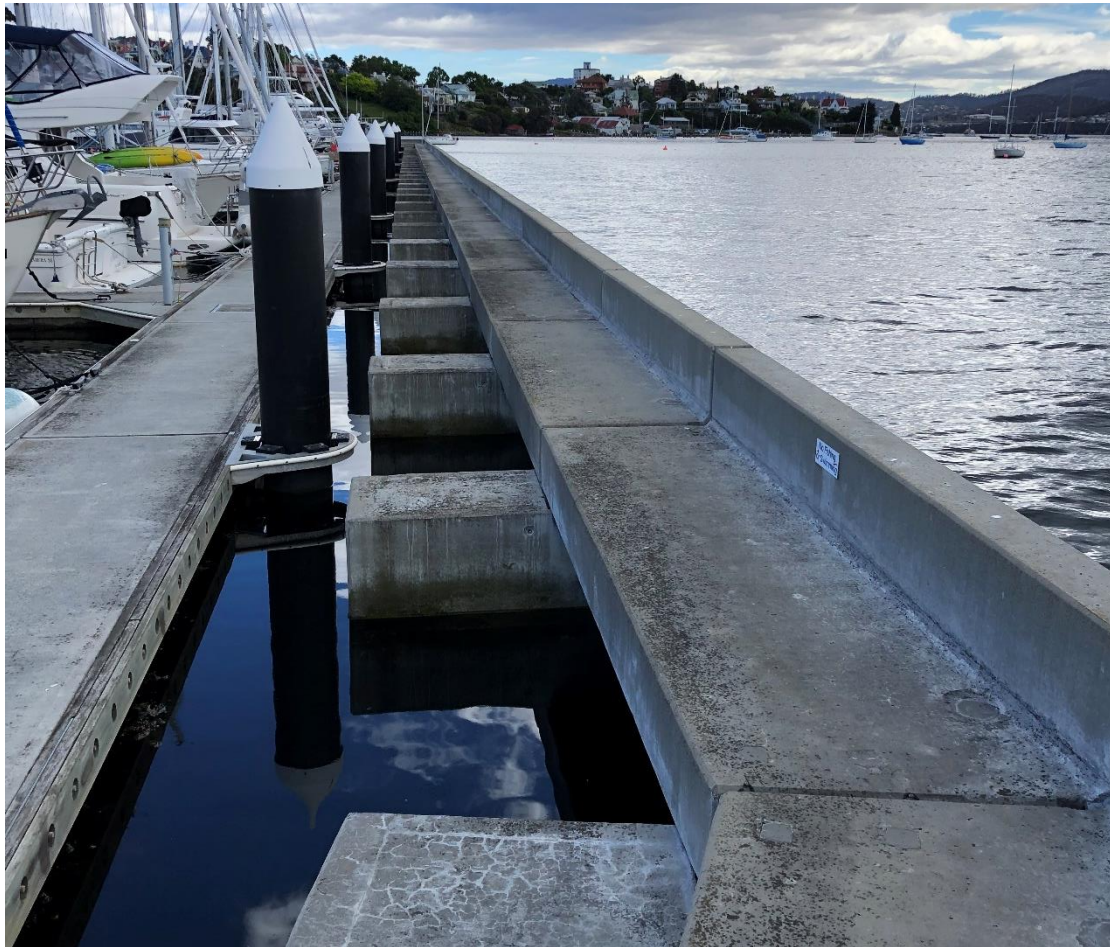
Royal Yacht Club Break-wall

Description of works: 240m long piles break-wall. Average 12m water depth, painted steel piles driven, precast headstocks, concrete pours out on the water.

13t precast wave panels and underwater bolted connections.

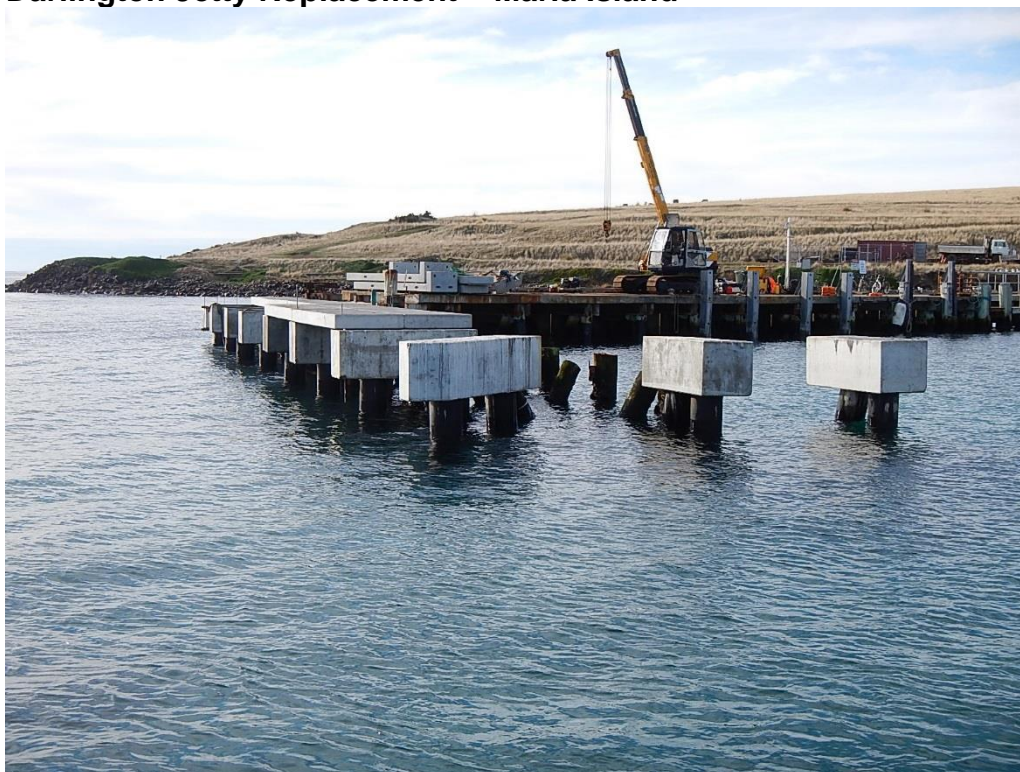
Darlington Jetty Replacement – Maria Island

Replace timber jetty with concrete wave panels with reinforced concrete jetty and new wave panels. New wave panels were 4m deep and were supported on two rows of heavy steel UC's bolted back to the piles. Difficult logistics of building a large structure 10 NM off shore from the east coast. Very exposed site to prevailing westerlies made construction difficult.

We did have a few issues with this job which were good lessons. This design had a heavy UB underwater whaler system to hold the bottom of the precast panels which were about 1.5m wide and 6m long. After the job was finished the s/s bolts rattled loose and the whaler system dropped and slid down the poly

There have also been ongoing issues with fasteners working through the concrete with the continuous working, making them needing regular tightening. Initially we swapped out all the 316 s/s for galvanised fasteners and that helped. Both the DSS and RYCT break-walls had grout keys between panels which seem to be the best way to stop these things working loose on the fasteners system
